## **AHERA RE-INSPECTION**

Woodside High School  
199 Churchill Avenue  
Woodside, CA 94062

Project No.: 20-011  
Date: February 18, 2020

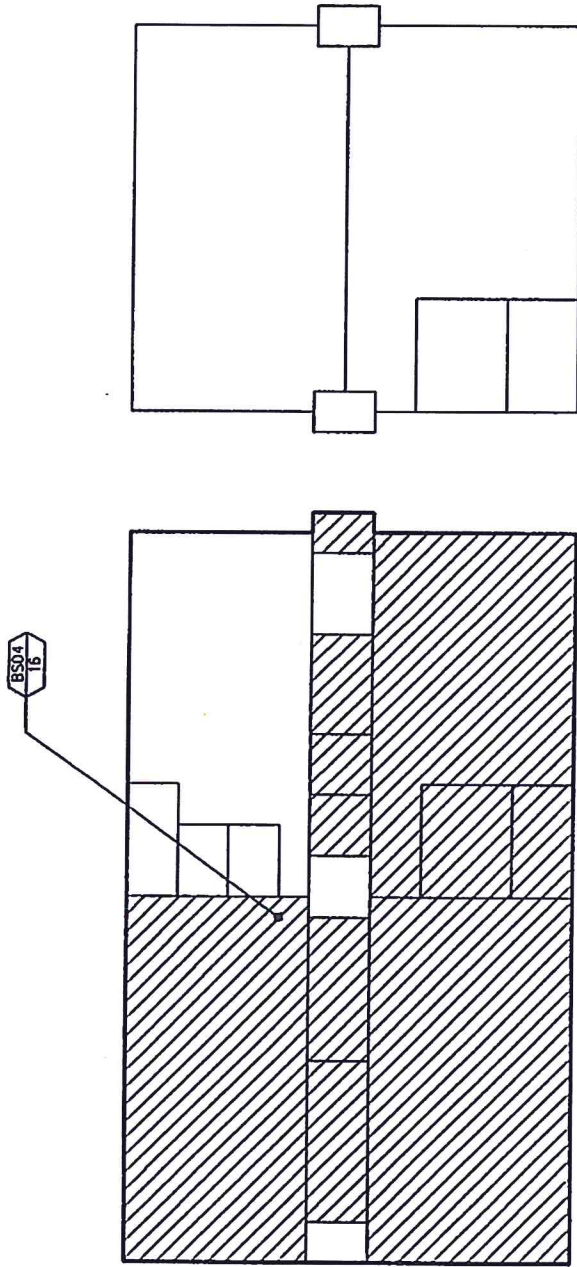
AREA  
COMPLIANCE PROGRAM  
05-9018-005-009  
SEQUOIA UNION SCHOOL DISTRICT  
WOODSIDE HIGH SCHOOL  
BUILDING C-11 TO C-12

BS04 75%  
THROUGHOUT 2

NOTE: THIS DAMAGE AREA  
CODE APPLIES THROUGHOUT THE  
BUILDING.
