<b>Type of Services</b>	<b>Phase I Environmental Site Assessment and Soil Quality Evaluation</b>
<b>Location</b>	<b>Phase 2 Lab Building Project Menlo Atherton High School 555 Middlefield Road Atherton, California</b>
<b>Client</b>	<b>Sequoia Union High School District</b>
<b>Client Address</b>	<b>480 James Avenue Redwood City, California 94062</b>
<b>Project Number</b>	<b>166-5-29</b>
<b>Date</b>	<b>September 14, 2016</b>

<b>Type of Services</b>	<b>Phase I Environmental Site Assessment and Soil Quality Evaluation</b>
<b>Location</b>	<b>Phase 2 Lab Building Project Menlo Atherton High School 555 Middlefield Road Atherton, California</b>

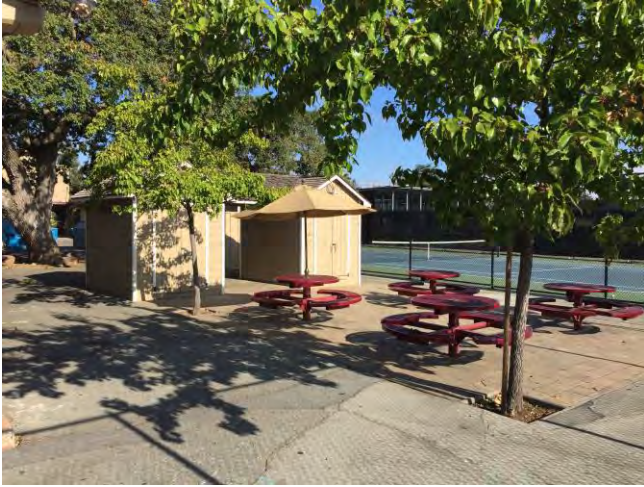
The eastern portion of Area 1 consisted of a tennis court on the northeast corner of the Site which was surrounded to the north, west, and south by asphalt concrete (AC) paved pedestrian walkway areas. Located on the AC paved walkway areas to the south of the tennis court were four small wood sheds. Mr. Oliver indicated three of the sheds were installed in 2006. Access to the interior of the sheds was not provided; Mr. Oliver indicated the sheds contained sporting equipment. The fourth shed reportedly was constructed in 1996 by enclosing a carport. The shed was observed to contain miscellaneous items such as school supplies, extra trash bins, abandoned bicycles, whiteboards, ladders, window screens, fence posts, etc.

Photograph 1 (looking northwest). Sheds south of tennis court in Area 1.

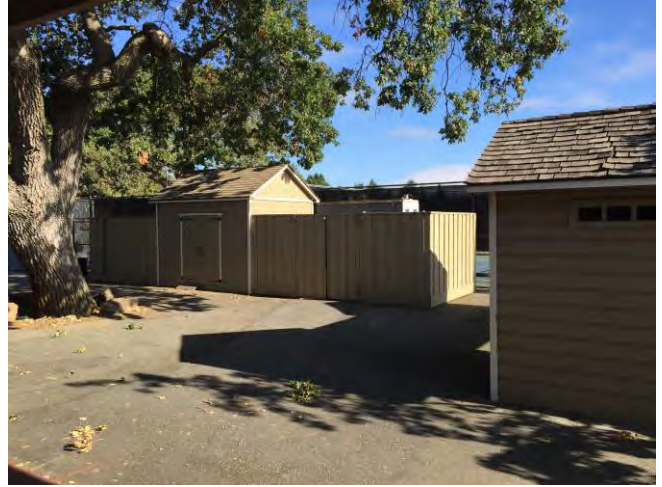
Photograph 2 (looking northwest). Sheds south of tennis court in Area 1. Top of emergency generator can be seen behind wood fenced enclosure.

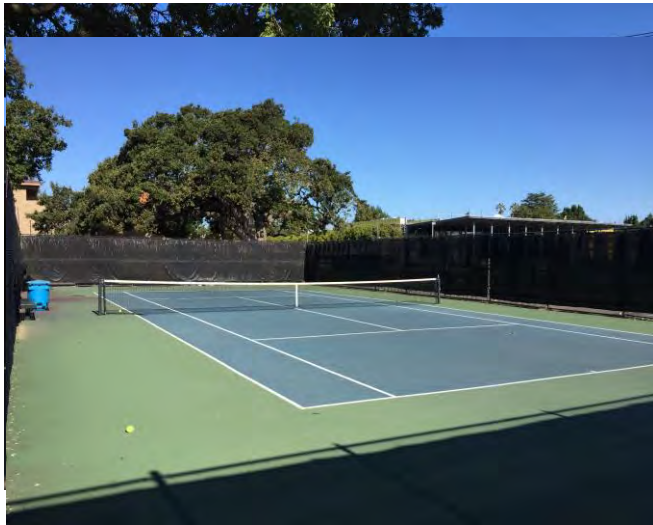
Photograph 5 (looking northwest). Tennis court in Area 1.

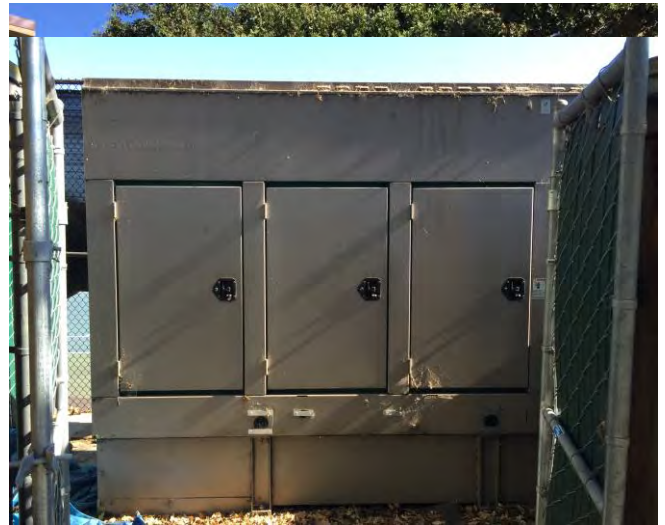
Located immediately adjacent to the south of the tennis court was also a small concrete utility pad mounted emergency diesel generator, self-contained in a metal panel housing. Mr. Oliver indicated the generator unit was installed in in 1997 and no underground fuel storage was associated with the generator. Fuel was stored in an above ground 50-gallon tank located within the metal housing of the generator unit. The utility pad on which the generator was mounted and the pavement surrounding the pad appeared to be in good condition and no staining was observed at the base of the generator.

Photograph 6 (looking north). Emergency generator south of tennis court in Area 1.

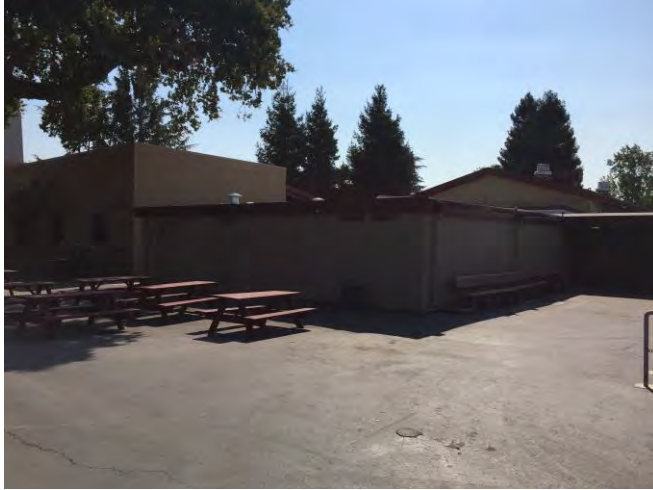
Photograph 11. (looking southwest). Bathroom building.

Laboratory analyses of the soil samples collected at the Site did not detect OCPs, lead, or PCBs above Environmental Screening Criteria except for chlordane detected in one soil sample (SB-6) collected on the north side of the restroom building at a concentration of 1.1 mg/kg. The Environmental Screening Criteria for chlordane is 0.44 mg/kg. The 95 percent upper confidence limit concentration for chlordane is 0.304 mg/kg. Historically, chlordane was commonly used for pest control near the foundations of wood framed buildings.

Based on the results of the soil samples collected from other areas near the restroom building, soil with chlordane concentrations that exceed its Environmental Screening Criteria appears limited to the north side of the restroom building. Although the 95 percent UCL concentration for chlordane is less than its Environmental Screening Criteria, due to the anticipated small volume of soil (possibly less than 10 cubic yards) we recommend the chlordane impacted soil near the SB-6 location be excavated and disposed at a permitted facility.

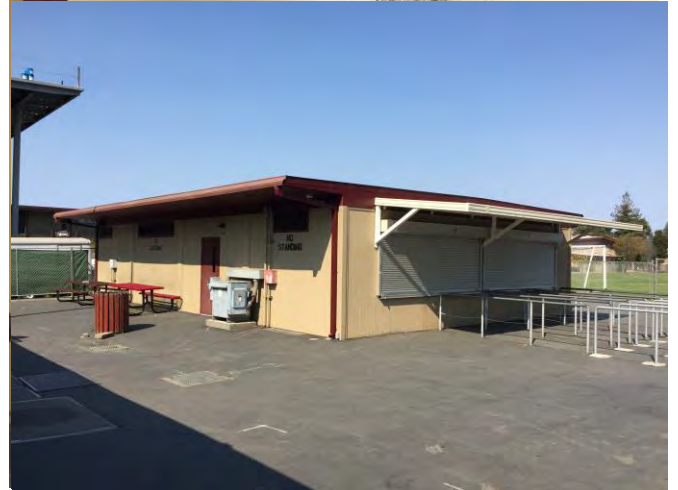
Photograph 12. (looking northeast). Food service building.

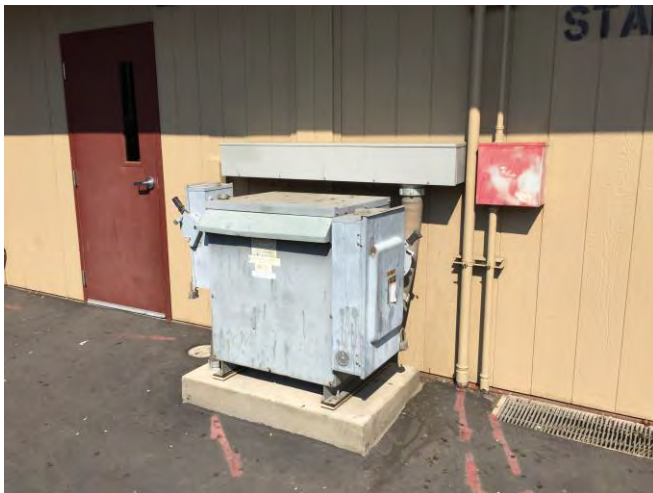
Along the western edge of Area 1 was a wood-framed restroom building and on the northern edge was a food service building, also of wood-framed construction. Directly adjacent to the food service building along its western exterior wall was a small concrete utility pad mounted transformer. The utility pad on which the transformer was mounted and surrounding pavement appeared to be in good condition and no staining was observed at the base of the transformer.

Photograph 13. (looking northeast). Small transformer on the western exterior wall of food service building.

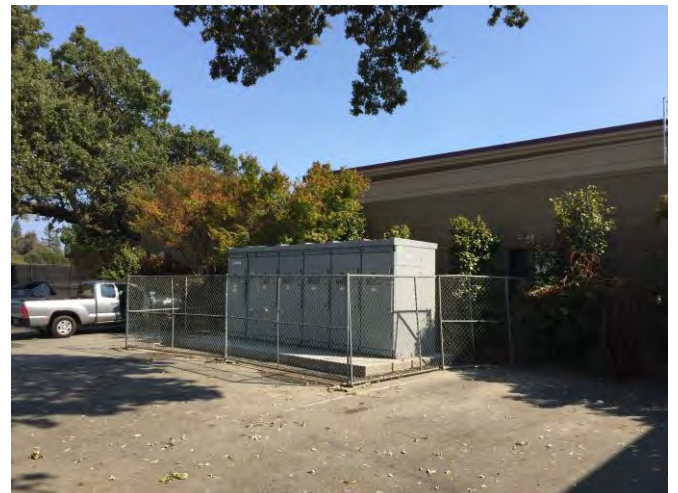
Photograph 14. (looking southeast). Electrical switch gear along northern exterior wall of library building.
